INFLUENCE OF THE WAYS FOR REMOVING THE EXCESS OF COMPOSIT RESIN CEMENT MATERIALS ON THE SURFACE ROUGHNESS DEGREE

Abstract: The microstructure of resin-based cement materials is mostly composed of hybrid fillers. The improvement of chemical- and micro- structure of resin-based cement materials decreased the degree of the surface roughness.

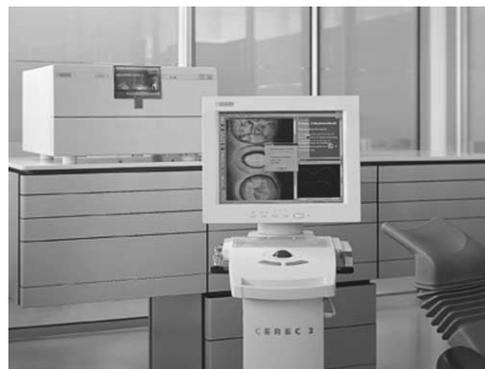
Figure 1. Cerec3D CAD-CAM system

In vitro experiment performance included the scanning of dental preparations. Tooth preparation for scanning involved application of a thin film of liquid (CEREC[®]-liquid, VITA, Bad Sackingen, Germany) and powder (CEREC[®]-powder, VITA, Bad Sackingen, Germany). The scanning was performed by using the optical Cerec[®]3D system intra-oral scanner. Computer-aided design was performed by using the Cerec[®]3D software, version 3.10. The crown design was chosen from the existing program database. The thickness of cement film space was 30 μ . (Fig. 1)

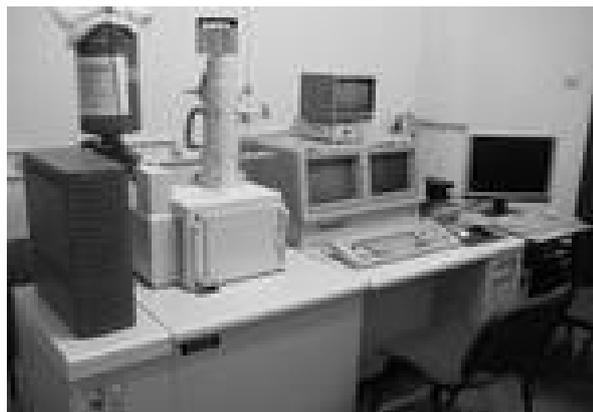
Figure 2. JOEL JSM-5800-(SEM)

Three crowns have been cemented with each of the mentioned cementing types on the prepared teeth. The scanning electronic microscope JOEL JSM - 5800 - SNING MICROSKOPE (SEM) was used for observing the exposed cement film surfaces at the demarcation level (Fig.2).

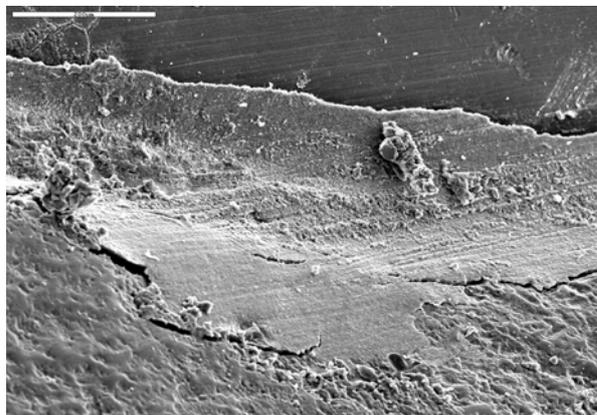
Figure 3. Surface texture (horizontal direction)

The results of the research show the presence of a different degree in surface roughness of the cement at the demarcation level. The sample snapshots involving the removal of excess cement film using a cotton-roll in horizontal direction show less degree

of roughness on the surface texture, horizontally oriented. (Fig. 3, 4)

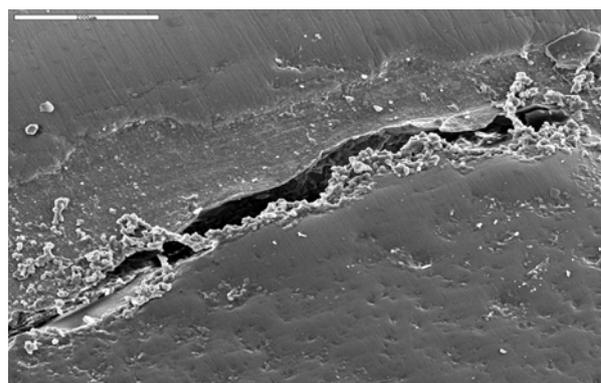
Figure 5. Surface texture (vertical direction)

The samples which involve the removal of cement using a cotton-roll in a vertical direction also show lesser degree of roughness, with the vertically oriented texture (Fig. 5).

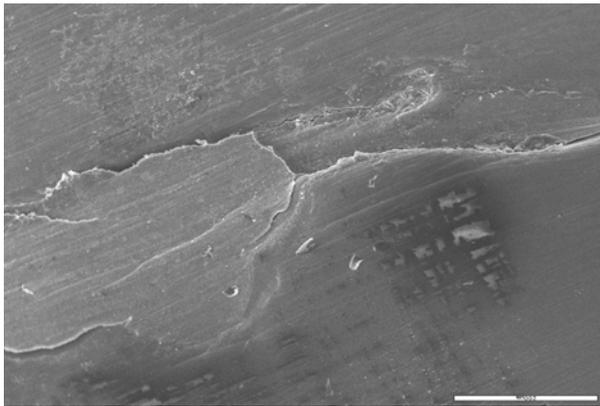
Figure 6. Polished surface

Minimum roughness degree was observed on the samples which involved the cement removal by using borers, which were smoothed with aluminum oxide abrasive instruments (Fig.6,7).

The lowest degree of roughness was observed on the polished surface, which was the most favorable one from the clinical aspect. In addition, there

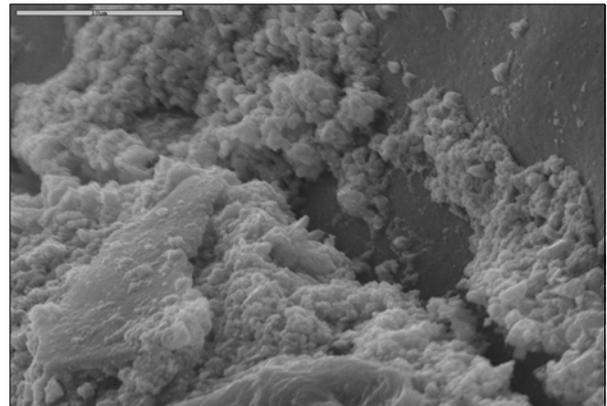
Figure 9. Expressive surface roughness (magnification 500x)

The expressive roughness, as well as the brokenness of cement surface, noted on the samples which involved the cement material, caused its breaking off 5sec after the light polymerization. The expressive roughness with the texture that is prominent outside of the tooth-crown bond which, in a practical sense, means that their location should be in the gingival sulcus area (Fig. 8, 9,10).

Several methods used for the removal of excess composite cement are present in clinical practice. One of the most commonly present procedures is the one that involves breaking off of the excess cement after the roentgenoscopy of 5-second duration, followed by the completion of the light polymerization in accordance with the manufacturers' prescription. The results of this experiment show that such cementing method causes the development of excessive surface irregularity, as well as a high degree of roughness.

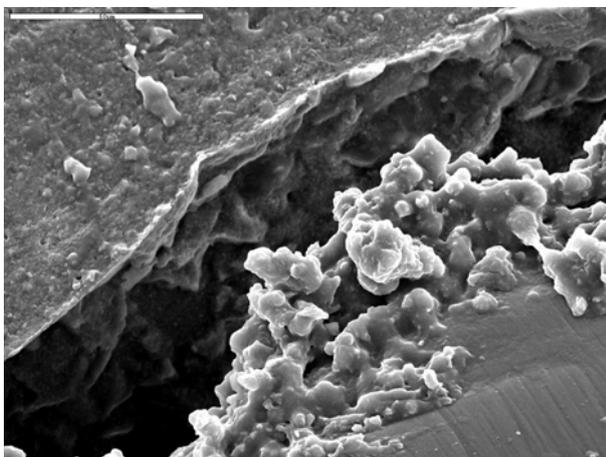
Figure 11- Marginal gap

Some clinicians use cotton-rolls to remove the excess cement. Within this experiment, the excess cement has been removed by using cotton-rolls in vertical and horizontal directions. The texture of the observed surfaces shows certain degree of roughness, but significantly lesser than in the previously mentioned methods. Considering the demarcation of preparation localized in subgingival region, such removal method can be recommended with the subgingival demarcations. In the case of subgingival demarcations, the cotton-roll could be replaced with a dental probe. Some literature data indicate that these methods of excess cement removal can affect the marginal sealing quality. The removal of excess cement before polymerization is one of the causes for appearance of gap between the cement material and hard dental tissues or a crown. Such submissions can be proven with the experimental results (Fig.11).
